Spot Safety Project Evaluation

Spot Safety Project # 14-97-018

**Spot Safety Project Evaluation of the Directional Crossover Installations on US 23 / 74
Located From the Jackson County Line to East of SR 1158 in Haywood County**

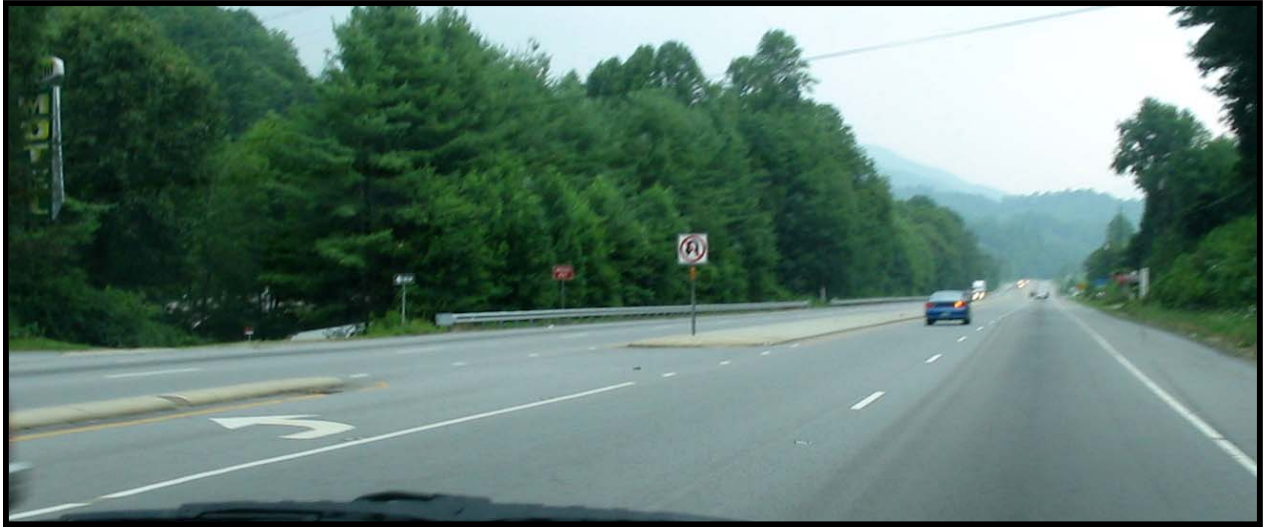
Driving northeast at Location 3

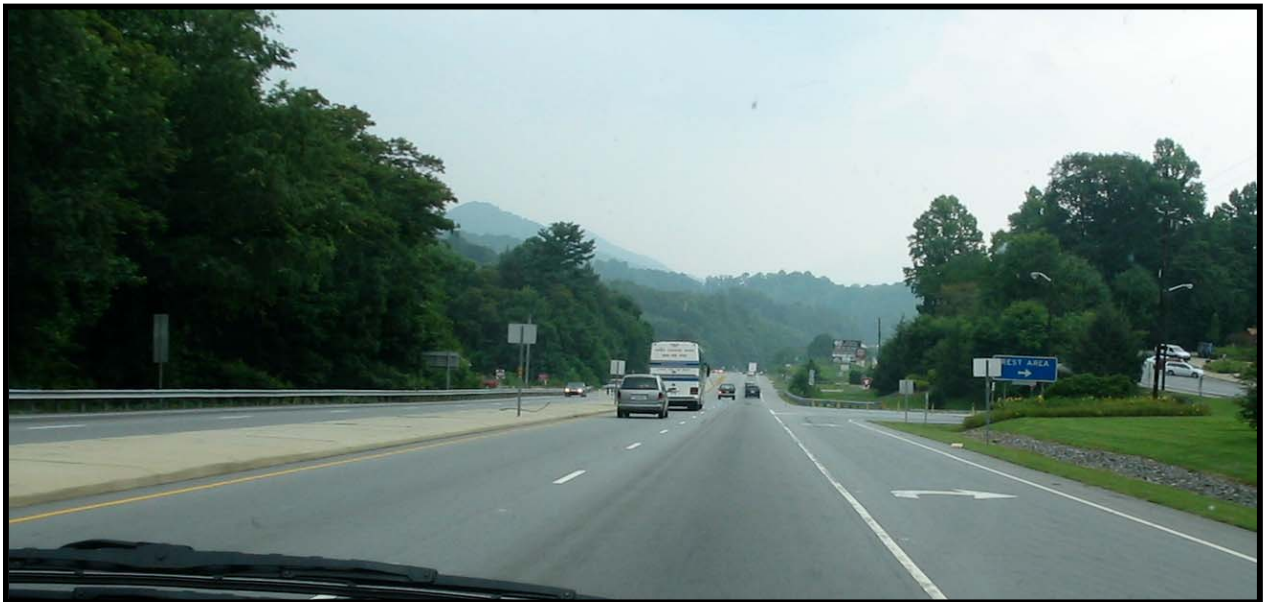
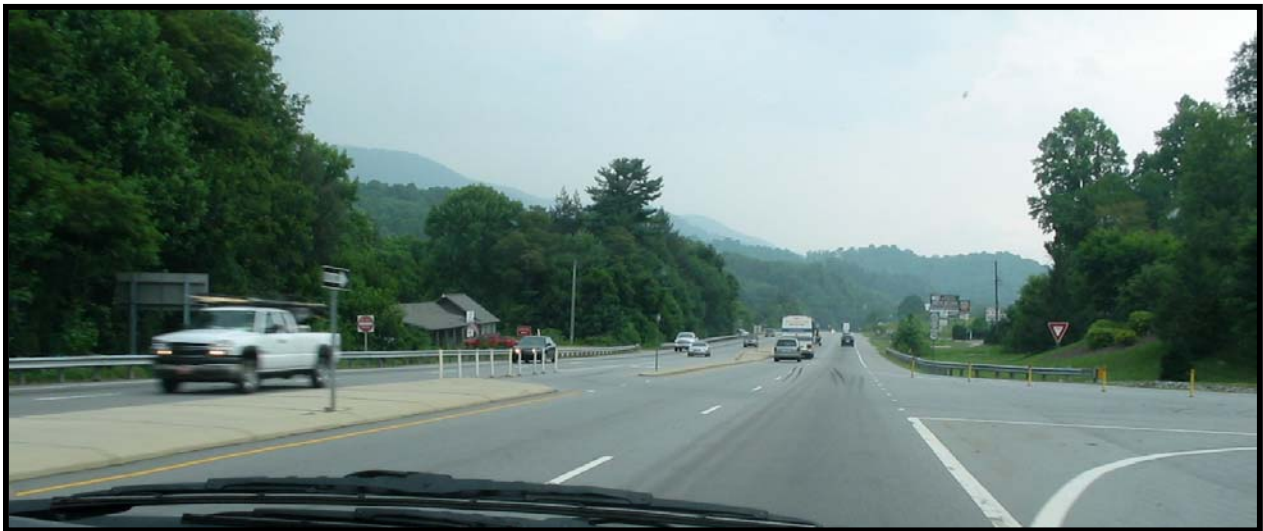
Driving northeast at Location 4

- Location 4 (installed poles to prevent left-turn movements from the Rest Area),
- Location 5 (installed raised pavement island and poles to prevent left-turn and through movements from the side street and left-turn movements from eastbound US 23/ 74 traffic),
- Location 7 (installed raised pavement island and poles to prevent left-turn and through movements from the side street), and
- Location 8 (installed raised pavement island and poles to prevent left-turn and through movements from the side street).

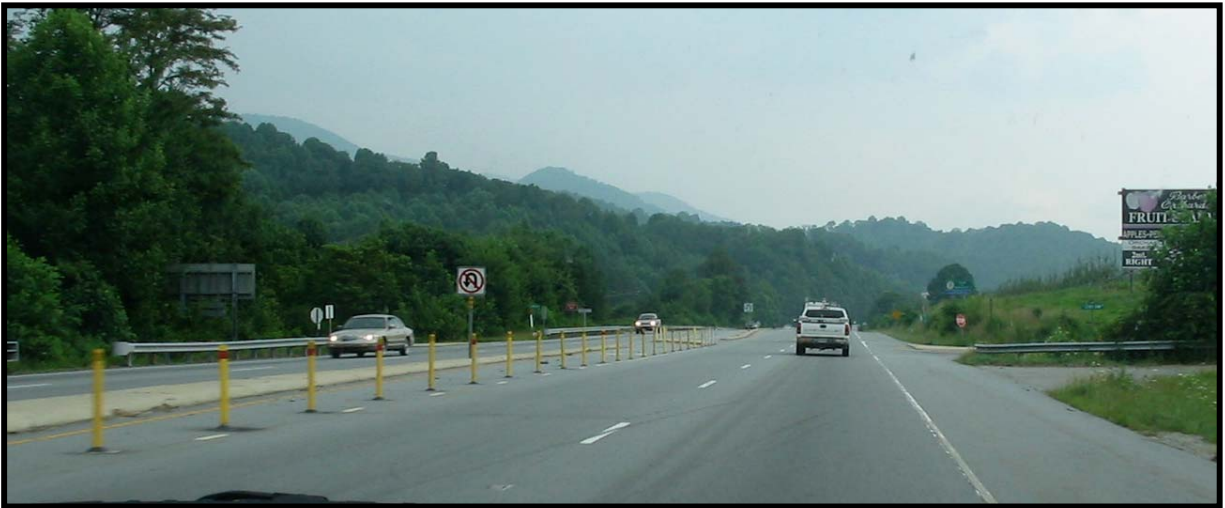
Driving northeast at Location 5

Location 5 experienced a 66.7 percent decrease in Total Crashes and a 100.0 percent decrease in Frontal Impact Crashes from the before to the after period. As with Location 4, the crash severity decreased dramatically. The number of injury crashes decreased from seven crashes in the before period to one crash in the after period. In addition to restricting side-street movements, the channelization at this location also prohibits left-turns for eastbound US 23/ 74 traffic.

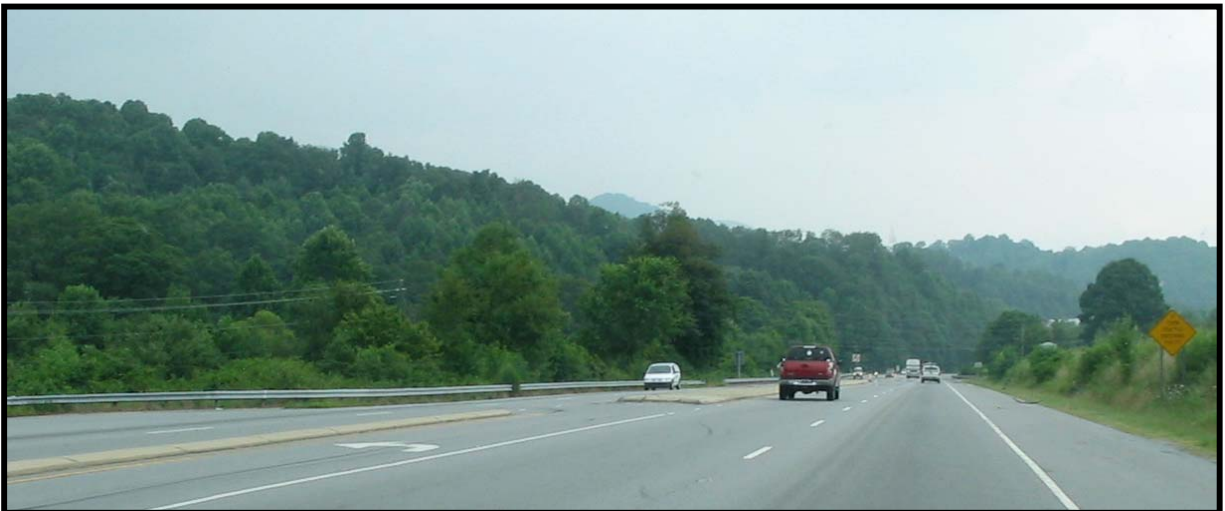
Driving northeast at Location 6

As previously stated, Locations 6 and 9 were constructed as part of the project improvement, to allow left and thru-traffic to U-turn back to their desired direction. Note that bulb-outs are provided to aid motorists in their U-turning movement. A combined total of two crashes occurred at Locations 6 and 9 in the after period. It appears that the treatment intersection has had minimal impact on the number of crashes at these two U-turn locations. The other non-treatment intersections within the strip also appear to have had a minimal change in the number of crashes from the before to the after period. Overall, Locations 1 through 9 experienced an 8.6 percent decrease in crashes after the spot safety treatments were installed. Please see the attached *Treatment Site Location Photos*. Photos are provided for Locations 3 through 9.

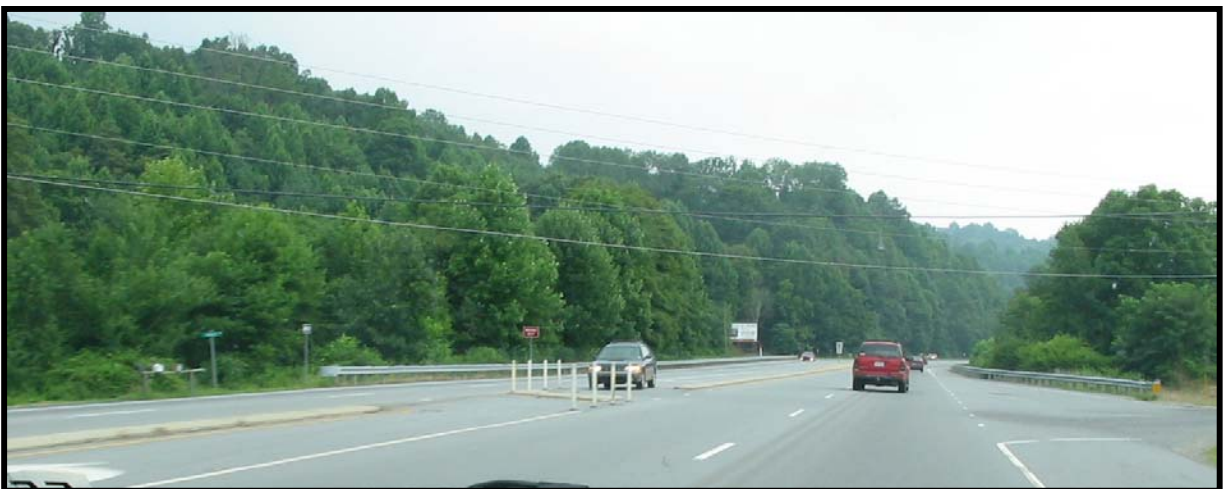
Driving northeast at Location 7

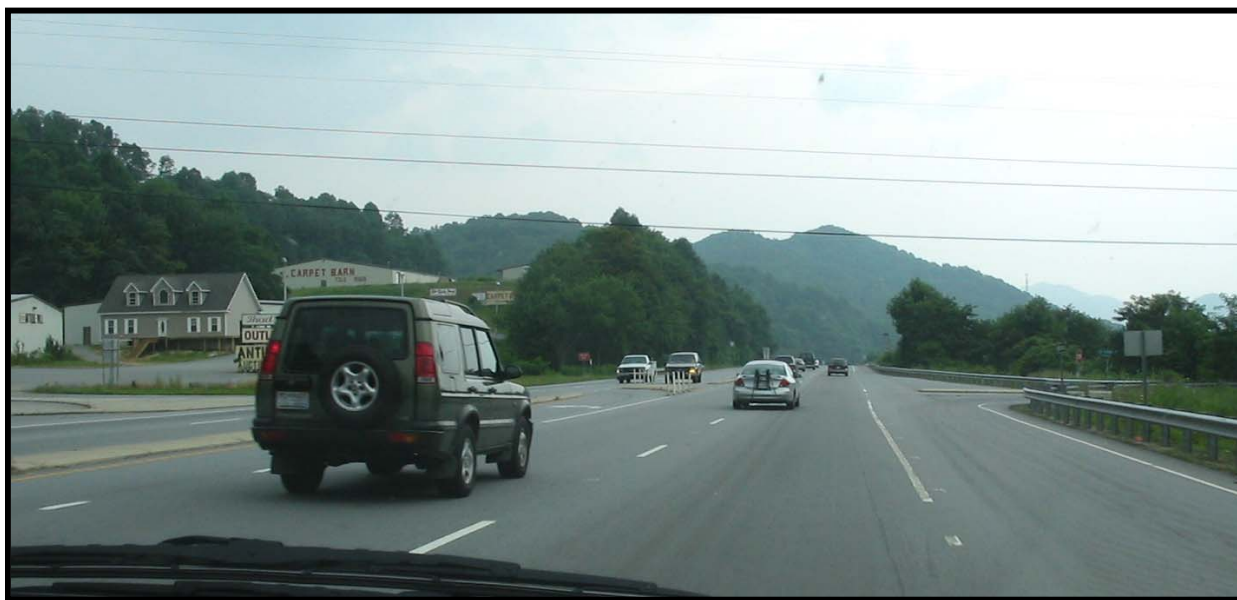
Driving northeast at Location 8

Location 8 experienced a 42.9 percent decrease in Total Crashes and an 84.6 percent decrease in Frontal Impact Crashes from the before to the after period. The Frontal Impact Severity Index increased by 53.6 percent, which is attributed to a fatal injury crash in the after period. The fatal crash involved a westbound travelling motorist making a left-turn movement in front of an eastbound motorist. One Rear-End crash also resulted in a class A injury in the after period. The directional crossover did correct the predominant Left-Turn, Different Roadway crash trend that resulted in two fatal injury crashes in the before period.

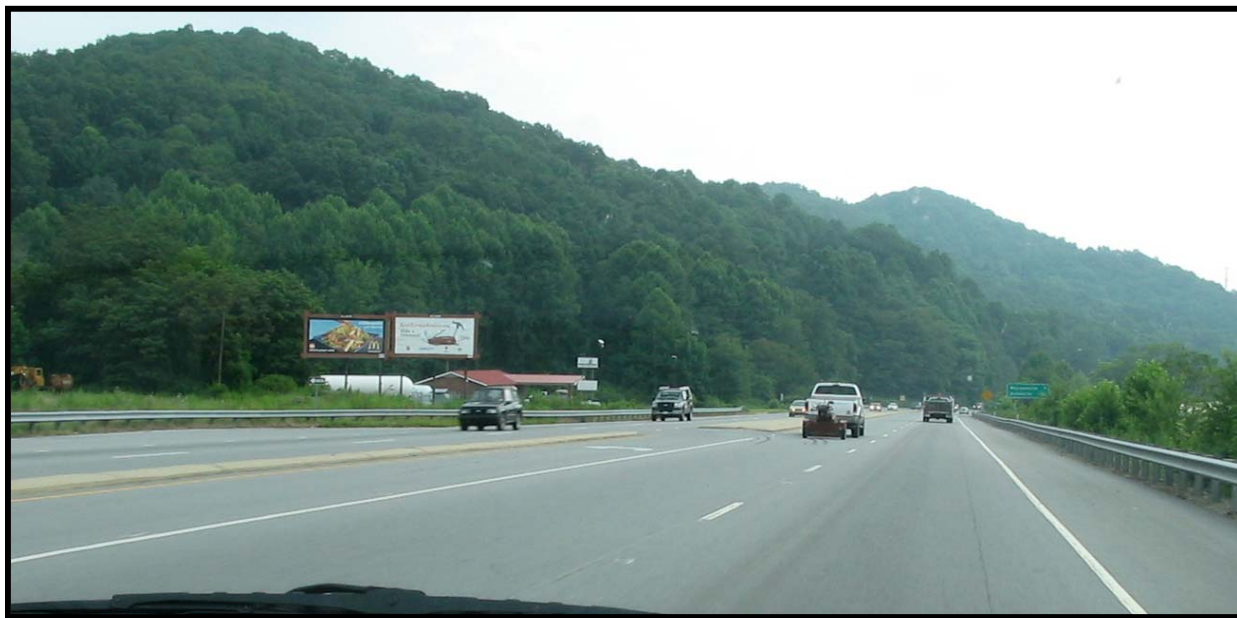
Driving northeast at Location 9

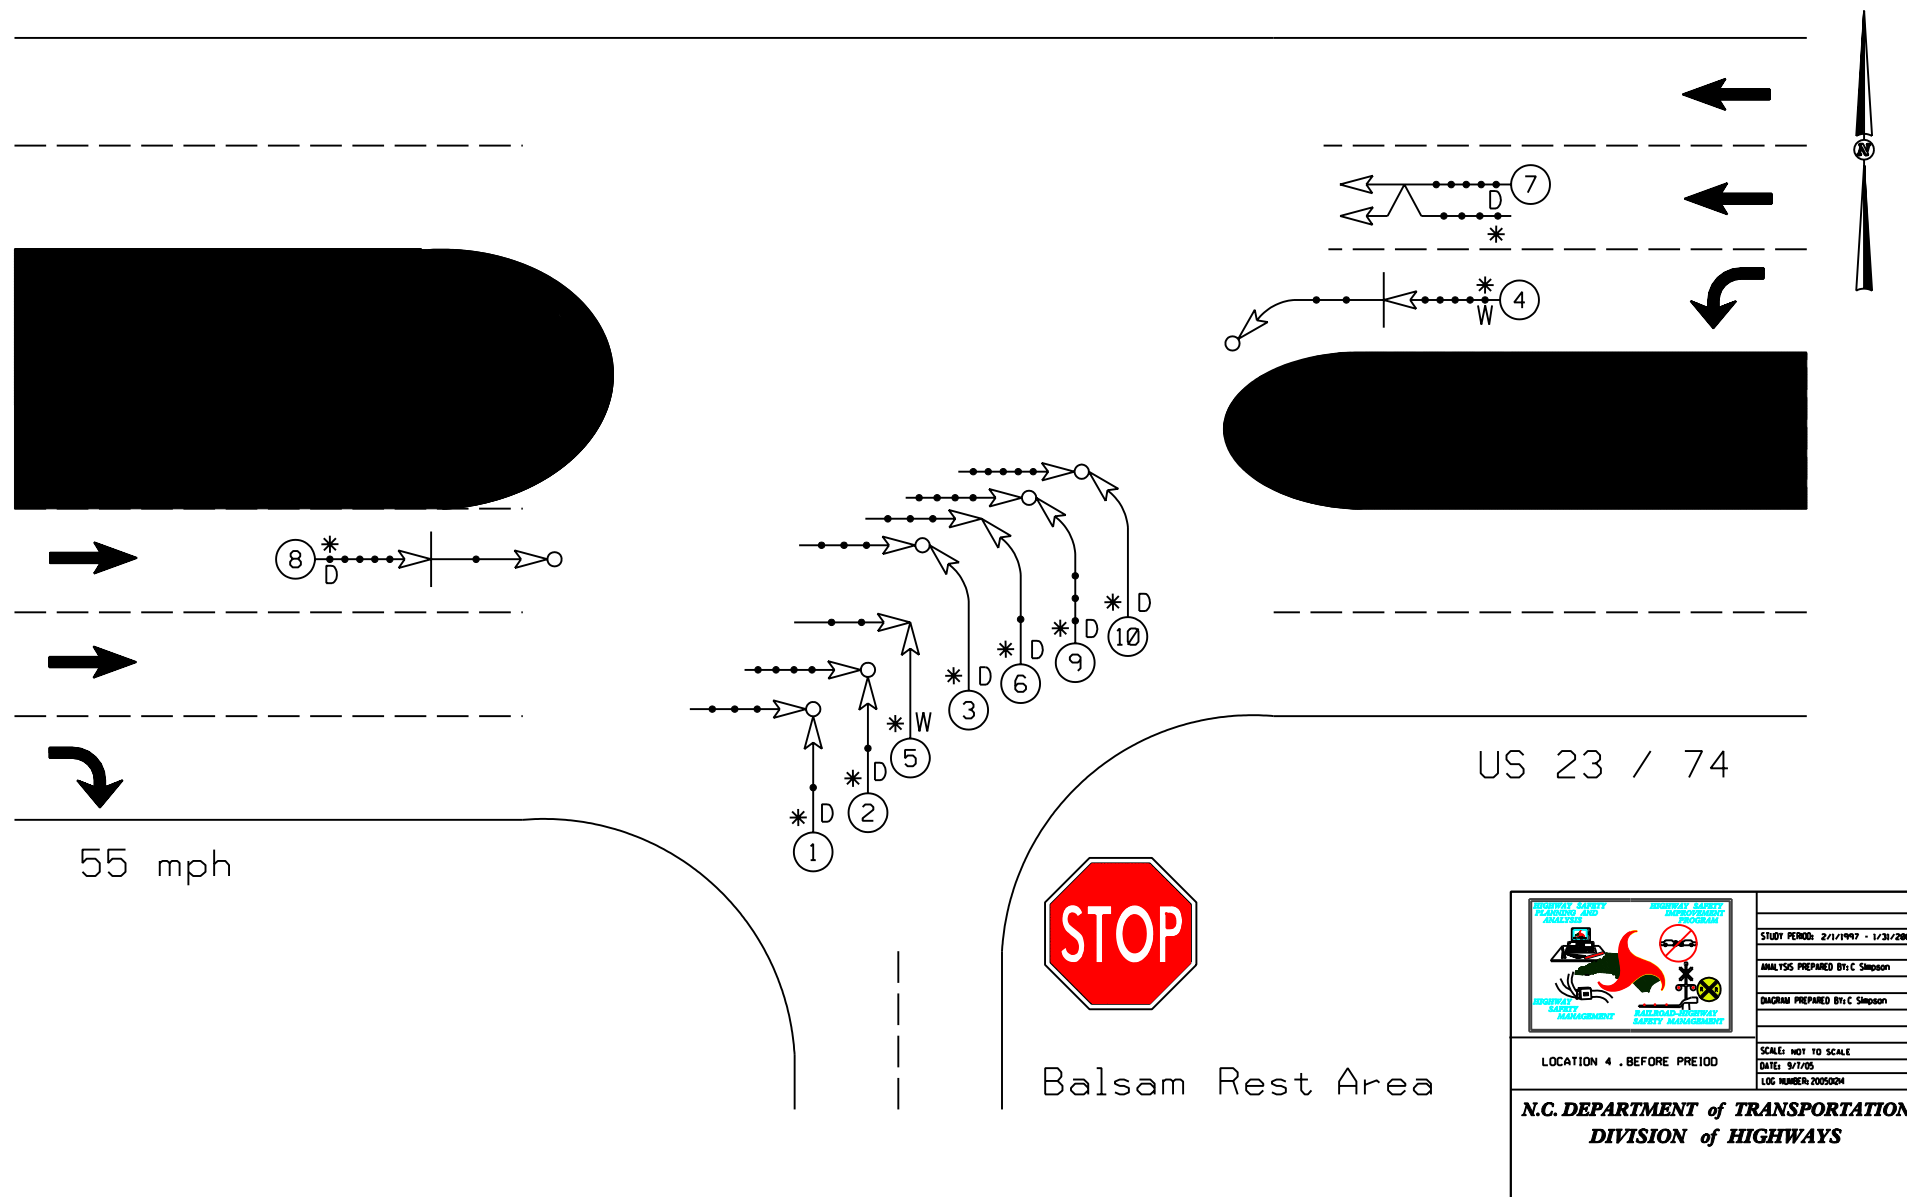
Location 4. US 23 / 74 at Balsam Rest Area
Haywood County
February 1, 1997 - January 31, 2000
Before Period - Total Crashes

Location 4 experienced a 20.0 percent increase in Total Crashes and a 71.4 percent decrease in Frontal Impact Crashes from the before to the after period. The crash severity decreased dramatically. The predominant crash pattern in the before period (Left-Turn, Different Roadway) was replaced by a majority of low severity Rear-End crashes in the after period. Please see the Before and After Collision Diagrams provided for Locations 4, 5, and 8.

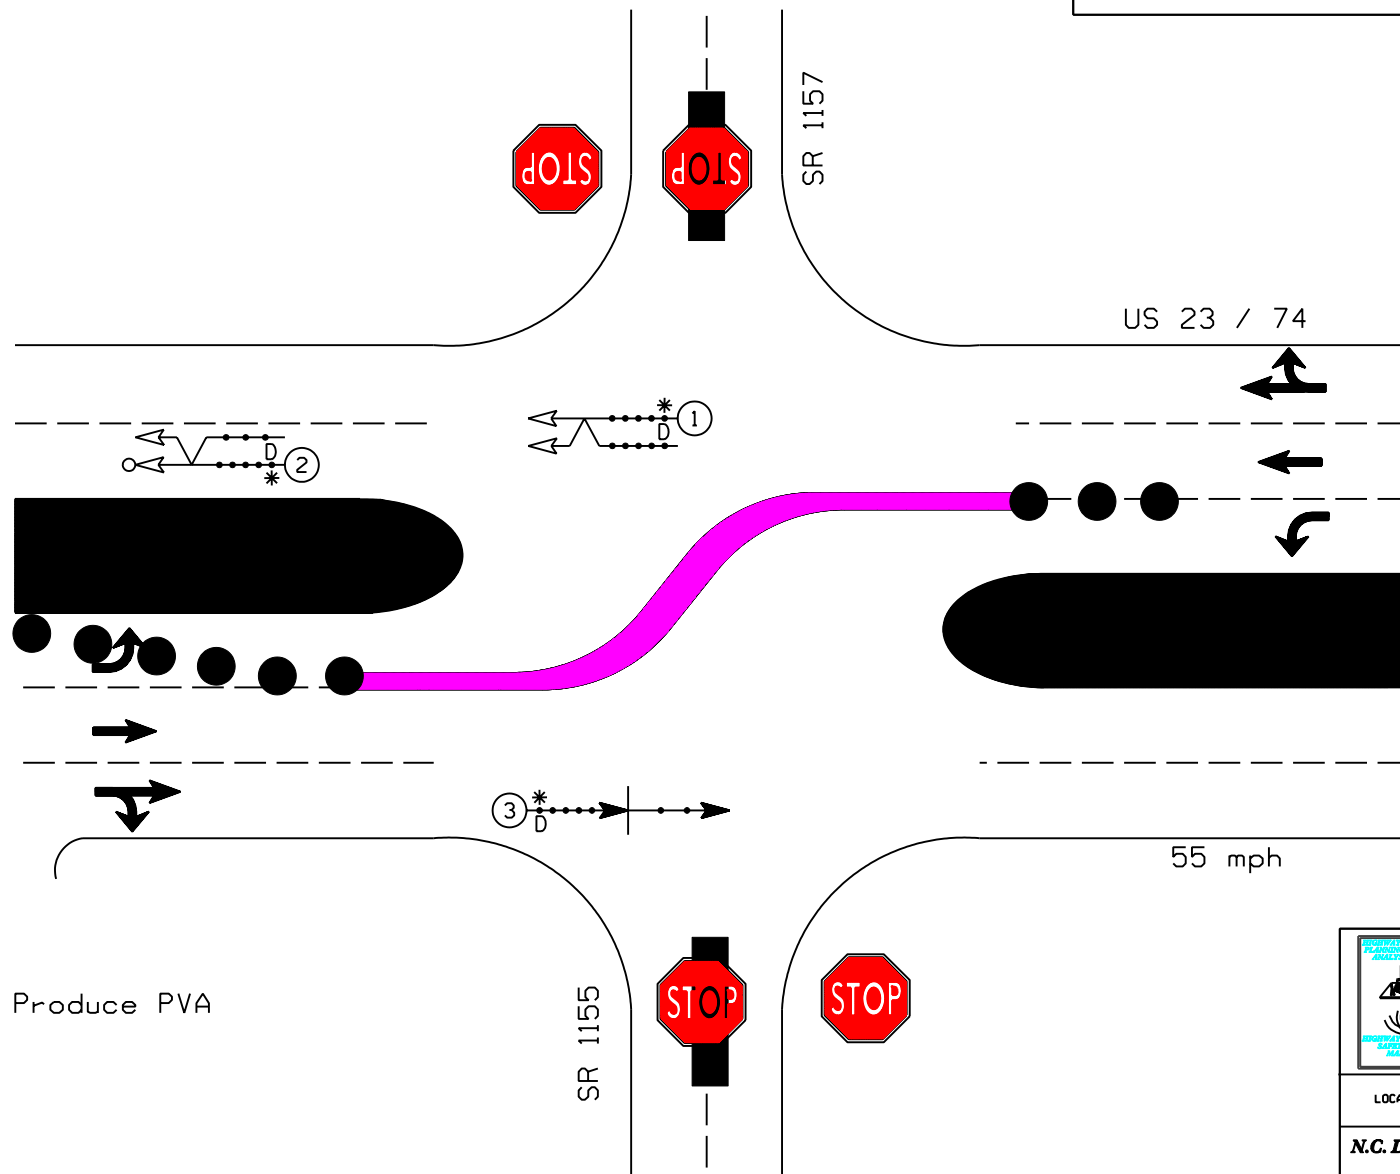
LOCATION 5 . AFTER PERIOD

Location 5. US 23 / 74 at SR 1157 / SR 1155
Haywood County
February 1, 2002 - January 31, 2005
After Period - Total Crashes
